CRANE ENGINEERING

**Supplemental Report on
Failure of New River MCAS FRP Pipe**

February 6, 2013

Your Client:	Talon Industries, Inc.
Date of Loss:	August 9, 2011
Crane File No.:	Z7561
Crane Descriptor:	MAT/TALON INDUSTRIES/MCAS JACKSONVILLE

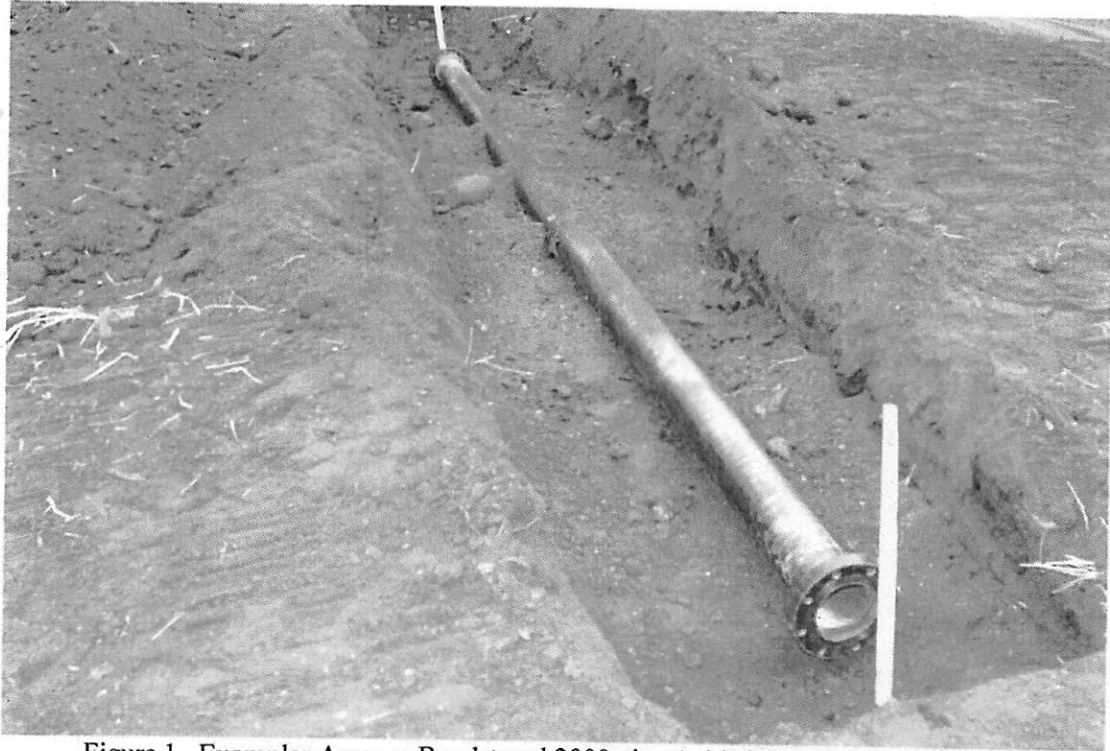
Figure 1. Exemplar Ameron Bondstrand 2000 pipe (with flanges) used for testing.

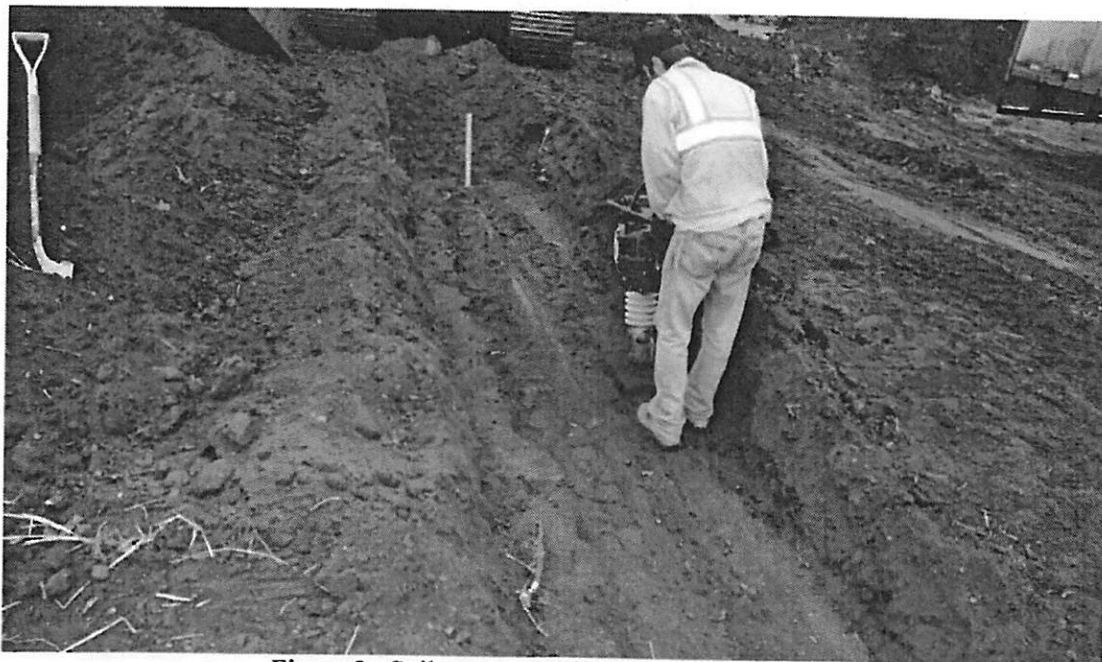
Figure 2. Soil was tamped around exemplar pipe.
